Manhole Inspection Summary

Manhole # S35AA_028MH

Insp Date: **11/13/07 10:28 AM**

Location Address: **102 e.madison**

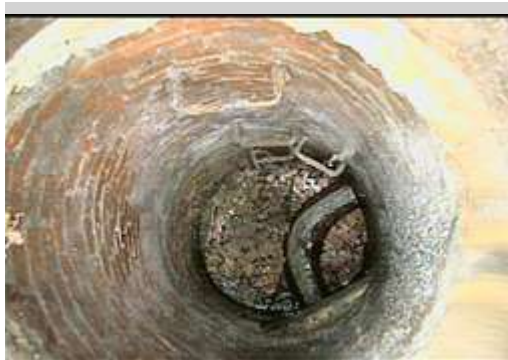
Defect 1

Steps Count: **6** Missing: **1** ☒ **Corroded**

missing/corroded steps

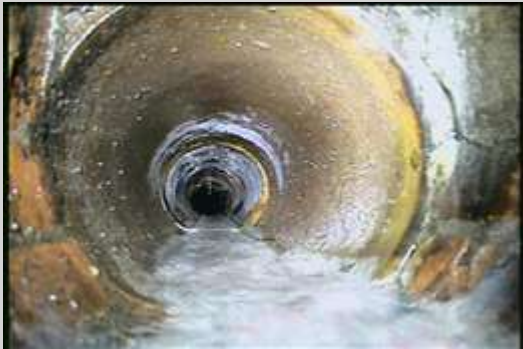
12 O'Clock Outflow

8 in. Circular Gravity Sewer
Pipe Out @ 12 O'Clock

Pipe Material: **Clay** ☐ Pipe Lined

Invert Depth: **12.45** (ft.) Flow Characteristics: **Slow**

Deposits: ☒ None ☐ Mud ☐ Sludge ☐ Debris ☐ Grease

Infiltration: **None** Pipe Seal Cond: **Unknown**

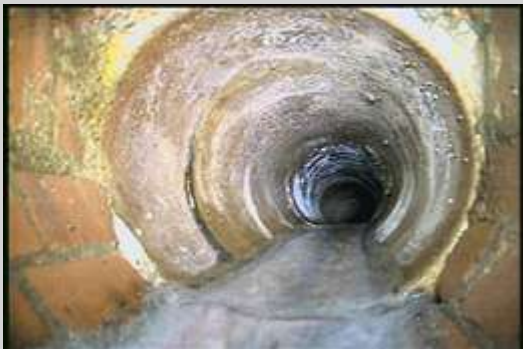
9 O'Clock Inflow

10 in. Circular Gravity Sewer
Pipe In @ 9 O'Clock

Pipe Material: **Clay** ☐ Pipe Lined

Invert Depth: **10.30** (ft.) Flow Characteristics: **Slow**

Deposits: ☒ None ☐ Mud ☐ Sludge ☐ Debris ☐ Grease

Infiltration: **None** Pipe Seal Cond: **Unknown**
